Manhole Inspection Summary

Manhole # S21AA_006MH

Insp Date: **9/11/07 9:18 AM**

Location Address: **815 LAFAYETTE-ALLEY-LANVALE**

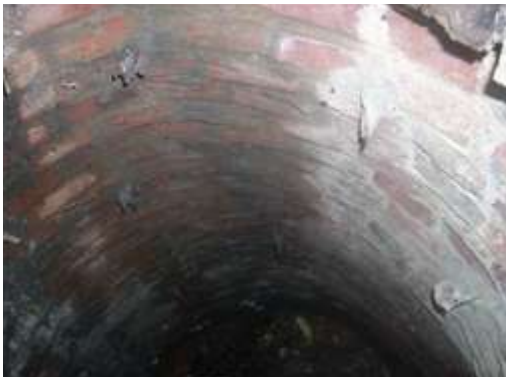
Defect 4

Count: **0** Missing: **5** ☐ Corroded

MISSING STEPS

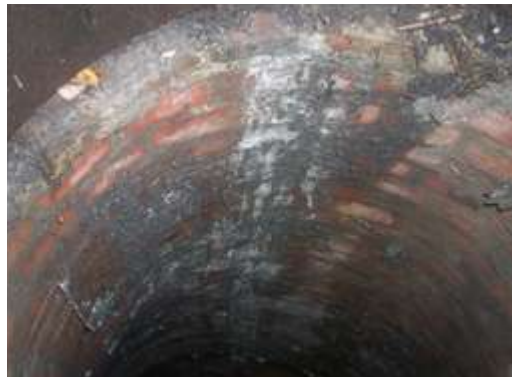
Defect 3

Infiltration: ☐ None ☒ **Joint** ☐ Cracks ☐ Mortar ☐ Roots ☐ Wall

INFILTRATION OF THE JOINT

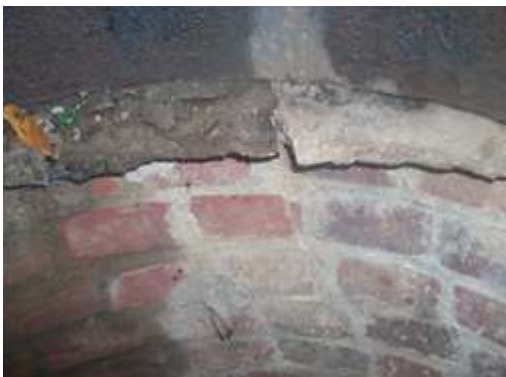
Defect 2

Condition: ☐ Sound ☐ Cracked ☐ Root Intrusion ☒ **Loose Brick** ☐ Deteriorated

LOOSE CONCRETE IN THE CHIMNEY

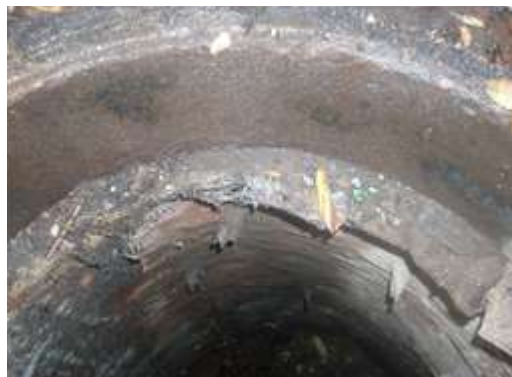
Defect 1

Offset: **1** (in.)

FRAME OFFSET

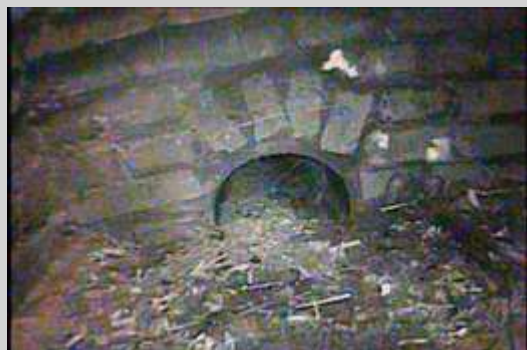
12 O'Clock Outflow

8 in. Circular Gravity Sewer
Pipe Out @ 12 O'Clock

Deposits: ☐ None ☒ **Mud** ☐ Sludge ☐ Debris ☐ Grease

Silt Depth: **2** (in.) Deposits Extent: **Medium**
